TECHNICAL & SAFETY COMMITTEE

INTERNATIONAL PARACHUTING COMMISSION (FAI)

Technical & Safety Information Notice No.	01/2009	W.N. 22
Date of Issue	28 January 2009	
Subject Matter and Applicability	<p>Following a riser failure on a PA Talon, the Australian Parachute Federation's Director Rigging, Jo Chitty, issued the following notice. This notice is of mandatory status for APF members, and it is being distributed by the Technical & Safety Committee of IPC to alert skydivers worldwide to the issues concerned.</p> <hr/> <p style="text-align: center;">IMPORTANT ANNOUNCEMENT FROM THE DIRECTOR OF RIGGING, AUSTRALIAN PARACHUTE FEDERATION. MANDATORY INSPECTION OF ALL 3-RINGS PRIOR TO NEXT USE</p> <p>RISER FAILURE On Sunday 18 January 2009, a PA Talon riser failed on opening. It was the left riser with RSL fitted. The reserve was deployed into the trailing main by the RSL resulting in a main reserve entanglement. Fortunately and with luck the jumper managed to attain sufficient reserve inflation to survive the landing with broken bones in his back and shoulder.</p> <p>During the investigation of his equipment it was found that the 3-ring closing loop had pulled out from under the confluence

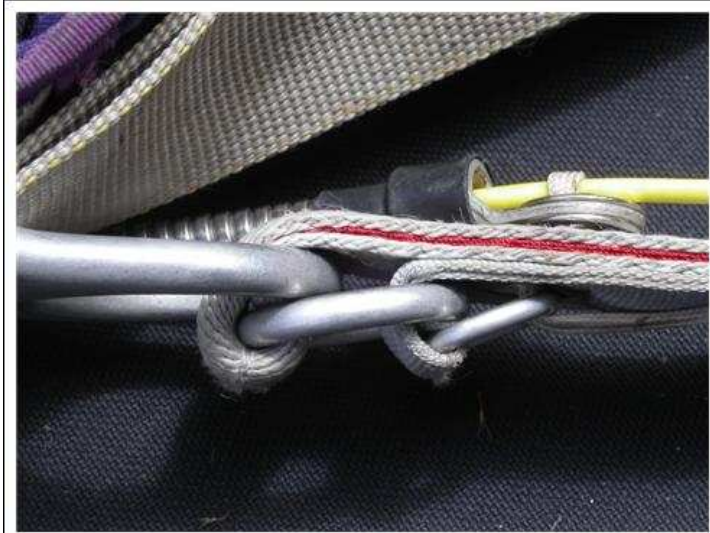
In August 2001 the APF promulgated APF Service Bulletin No APF010801-A 3-ring Inspection And Maintenance. The inspection, Part A, is designated **Mandatory**. This rig's reserve had been packed six times since the service bulletin was published, and numerous other times when the main was packed and possibly the 3-rings serviced. Had the service bulletin been applied it would have highlighted that the riser did not meet the criteria of the service bulletin; **the locking loop was too short.**

Due to the unique method of construction on this riser of bar-tacking across the loop it is probable that over a period of jumps some of the stitches had broken, due to the excessive load applied by the short locking loop until on this jump they failed completely allowing the loop to pull out of the riser, releasing it. It is impossible to visually inspect the stitching as it is covered by the confluence wrap; failure comes without warning signs. There was no kink in the left cutaway cable to warn of excessive loading. To prevent a similar event occurring especially when an RSL is fitted the following must occur.

MANDATORY INSPECTION in accordance with APF Service Bulletin [APF010801-B](#)* Issued 23rd January 2009 of all 3-ring riser assemblies before the next jump. Inspection to be noted on reserve packing card and marked on inside of front riser with APF010801-B using a fine tip paint pen so it will be visible even if the risers are black.

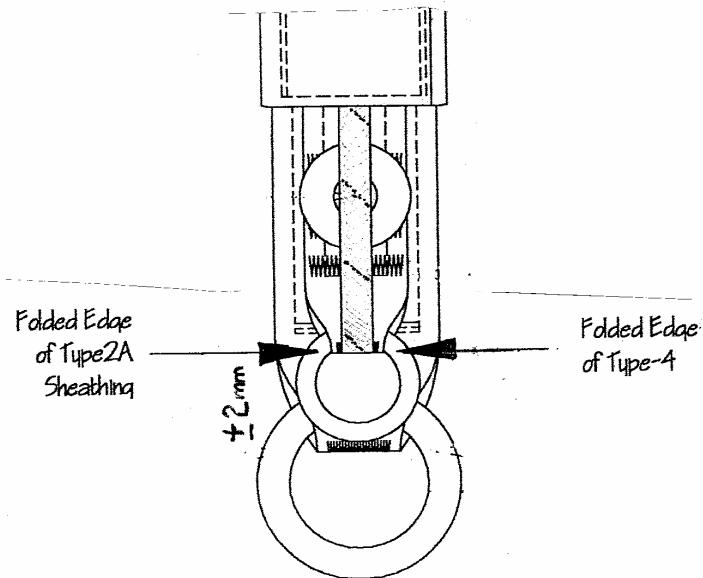
On all solo rigs and all types of riser style, one inch type 17 mini rings, type 8 mini rings and standard type 8 with the larger rings, the length of the locking loop should be level (+/- 2mm) with the end of the fold of the webbing that retains the small ring when the riser is laid flat with some tension applied to the small ring.

It is normal for new type 17 mini risers to be tight to interlock the rings, this is because they become more pliable with use, but the locking loop must still allow the housing some play and not pull the small ring against the riser, see side view on service bulletin.

Typical view of locking loop length
