TECHNICAL & SAFETY COMMITTEE

INTERNATIONAL PARACHUTING COMMISSION (FAI)

Technical & Safety Information Notice No.	02/2009 W.N. 23
Date of Issue	09 February 2009
Subject Matter and Applicability	<p>Sun Path Products Inc. SERVICE BULLETIN #SPSB005, dated February 3 2009 Re JH1013 (HIP RING MLW) AND JH1014 (4 RING MLW) RING DAMAGE</p> <p>SUBJECT: HIP RING AND 4 RING MAIN LIFT WEB INSPECTIONS</p> <p>IDENTIFICATION: ALL SPORT JAVELIN ODYSSEY HARNESS/CONTAINERS WITH <i>HIP RING OR 4 RING</i> MAIN LIFT WEB, WITH DATE OF MANUFACTURE BETWEEN <u>SEPTEMBER 2008 AND DECEMBER 2008.</u></p> <p>BACKGROUND: It has been brought to our attention that the hip ring on JH101-3 (Hip Ring Only) and JH101-4, (4-Ring) main lift webs, may have been struck by the needle used for installing the 5 cord harness stitching. This needle strike on the hip ring may cause damage to the Type 12 buffer, 5 cord stitching and possibly the Type 7 webbing. As a precaution, <u>a mandatory inspection of the hip rings is required for all systems with a date of manufacture between September 2008 and December 2008.</u></p> <p>Inspection must be completed before next use. The picture below is an example of a needle strike on a

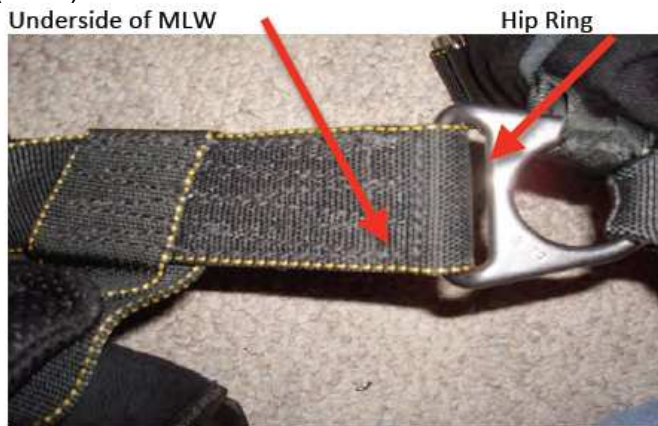
Turn Main lift web over, to expose the underside of the MAIN LIFT WEB (MLW).

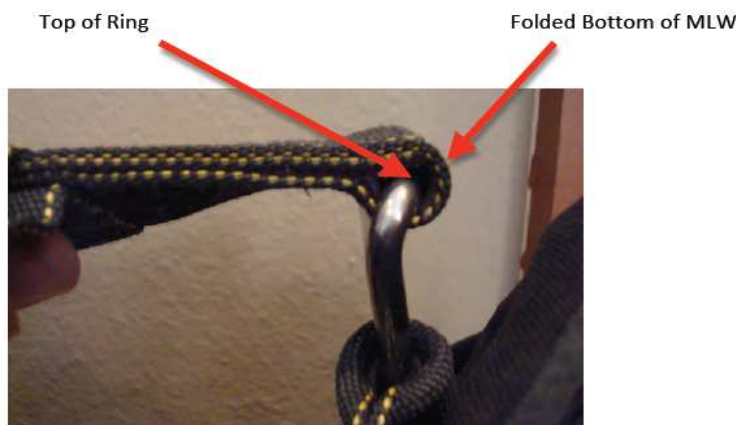
5. Rotate Hip ring and leg pad 90 degrees downward as to expose the top of the ring to the inside of the folded bottom end of the MLW webbing, as shown below.

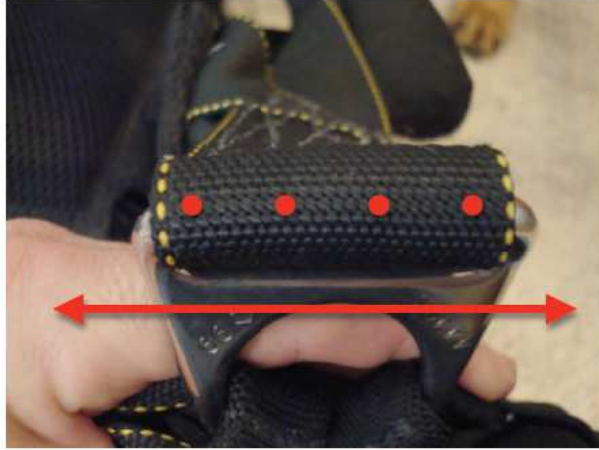
6. Move the hip ring back and forth (side to side) and rotate inside the webbing, while pressing the top of the ring through the webbing. If a needle strike is present, the rough spot on the top of the webbing bar of the ring will catch or snag on the TYPE 12 buffer on the inside of the TYPE 7 MLW. This will feel like a rough spot(s) on the top of the bar and cause a rough or snagging feel.

FEEL HERE FOR DAMAGED RING INSIDE WEBBING. DAMAGE WILL MOST LIKELY BE ALIGNED WITH THE BOTTOM POINTS OF THE 4 POINT STITCH PATTERN.

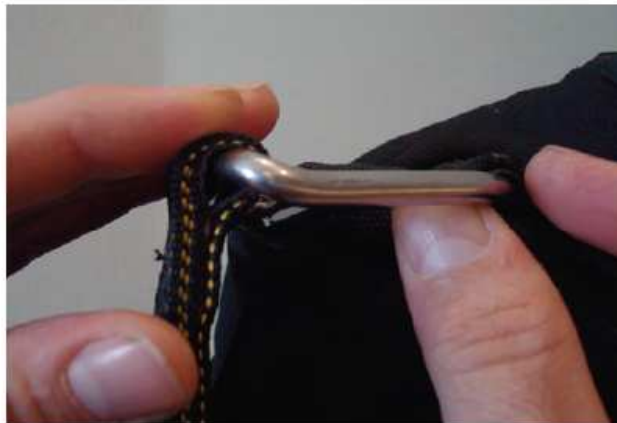
BACK AND FORTH/ SIDE TO SIDE MOTION

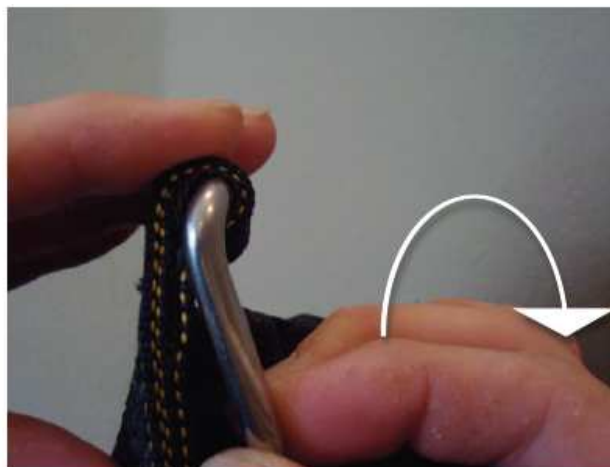
ROTATE DOWWARD
