# TECHNICAL & SAFETY COMMITTEE

## INTERNATIONAL PARACHUTING COMMISSION (FAI)

<b>Technical &amp; Safety Information Notice No.</b>	01/2010	W.N. 28
<b>Date of Issue</b>	27 April 2010	
<b>Subject Matter and Applicability</b>	<p><b>APF SERVICE BULLETIN NO. APF 100427</b> <b>Issued 27 APRIL 2010</b></p> <p><b>SUBJECT:</b> RIPCORDER PIN TEST <b>STATUS: MANDATORY.</b> This is a one-time TEST. One of two tests (either test 1 or test 2) must be performed and marked as per test procedure. <b>IDENTIFICATION:</b> Reserve ripcorders without markings to indicate manufacturer or previous test marking in rigs manufactured before July 2003 <b>BACKGROUND:</b> A reserve being closed after repack had the terminal pin of the ripcorder break as it was inserted into the closing loop. The rigger had closely inspected the pin prior to attempting to insert it and it was straight without any visible defect. The pin fractured 0.40" (10mm) from the shoulder at the place where the CYPRES closing loop would sit. The rig, a PA Talon was manufactured in 07/ 96 and the ripcorder was unmarked and presumed to be original as no other data was available on the log card to indicate otherwise. The ripcorder is outside

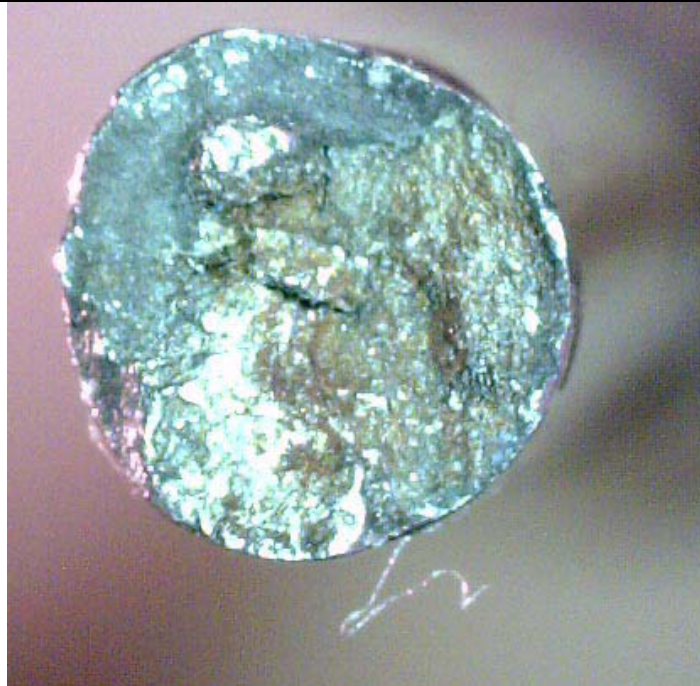
Pic. 3. Face of fracture, body side of pin. Brown discoloration on face may be corrosion or an impurity in the stainless steel. (The ripcord has been returned to the manufacturer for further analysis).

The location of the break is such that if it had been tested according to Capewell SB CW03-01 test 2 it may have passed the test as the fulcrum point in this test is 0.188 from the shoulder and is above the break. Test 1, an in the field in situ test on a packed rig would be an appropriate test as the load would be applied at a point consistent with the seating of the closing loop.

**APF ADVISORY:** That all reserve ripcords in rigs manufactured before July 2003 that do not have manufacturer's data or test indications on them be subjected to Capewell Service Bulletin CW03-01 **Field Test 1** and marked as indicated in the SB.

As test 2 may not be an adequate test due to the fulcrum point being too close to the shoulder an alternate test as described in Poynter's "the Parachute Manual" Vol. 2, Chapter 6.15. Inspection and Testing, where the pin tip is inserted ½" (12.5mm) into the test block and a load of 8lb is applied at right angles in four equispaced directions. This will test a greater length of the pin blade. The ripcord handle should then be permanently marked "APF-T2". The log card should also be annotated with the date and APF SB No.100427- T2.
