TECHNICAL & SAFETY COMMITTEE

INTERNATIONAL PARACHUTING COMMISSION (FAI)

Technical & Safety Information Notice No.	4/2013 SUPPLIER/VENDOR RECALL OF PS70104 HOUSINGS (METAL FLEX HOSING INC)						
	ALLJA101XX HARNESS CONTAINER ASSEMBLIES (JAVELIN						
	ODYSSEY) WITH METAL FLEX HOUSING BATCH # 33234A AND 33227, 375ID PS70104 HOUSINGS. W.N. 46						
Date of Issue	23 May 2013						
Subject Matter and							
Applicability	SUN PATH SERVICE BULLETIN SPSB009						
	DATE: May 23, 2013						
	SERVICE BULLETIN # SPSB009						
	SUBJECT: SUPPLIER/VENDOR RECALL OF PS70104 HOUSINGS (METAL FLEX HOSING INC)						
	STATUS: MANDATORY INSPECTION AND REPLACEMENT OF RECALLED HOUSINGS.						
	IDENTIFICATION: ALL JA101XX HARNESS CONTAINER						
	ASSEMBLIES (JAVELIN ODYSSEY) WITH METAL FLEX HOUSING BATCH # 33234 A AND 33227, .375ID PS70104 HOUSINGS. SEE SERIAL NUMBER LIST BELOW.						
	38159 38899 38945 38979 39013 39037 39058						
	38231 38900 38946 38980 39014 39038 39060						
	38453 38901 38947 38982 39021 39039 39061

SERVICE BULLETIN: MANDATORY INSPECTION (COMPLIANCE WITH METAL FLEX HOSING MATERIAL RECALL)

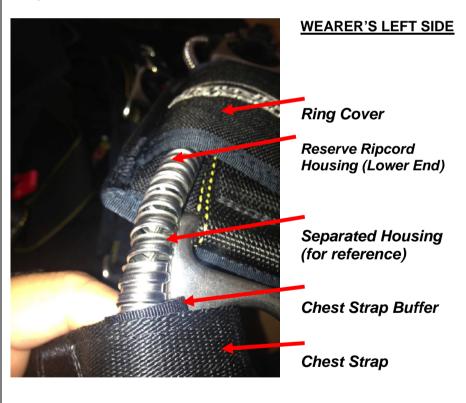
Who can inspect: Anyone can inspect this area. See photos below.

What to inspect: All JA101---XX harness container systems listed in table above. Inspect Reserve Ripcord housing.

PROCEDURE: If the serial number is listed in the above table, inspect the available exposed reserve ripcord housing. Locate the lower end of the housing, which is clamped to the Main Lift Web, just above the reserve ripcord pocket. Inspect the exposed length of housing from the

B. HOUSINGS ARE SEPERATED/UNRAVELLED: 1. GO TO http://www.sunpath.com/support/HousingReplacement.pdf FOR FURTHER INSTRUCTIONS ON REPLACEMENT OF THE SUBJECT HOUSINGS. 2. AT TIME OF REPLACEMENT, FILL OUT WEB FORM AND SUBMIT at http://www.sunpath.com/MetalFlexRecall.html; NOTE ON PACKING DATA CARD AND RIGGER LOG BOOK, SPSB009 COMPLETEDREPLACED. 3.NO FURTHER ACTION REQUIRED.
	 <i>Resolution:</i> A: Housing is intact and will be monitored and replaced at the inspection/repack cycle. 1. NOTE ON PACKING DATA CARD, SPSB009 COMPLETED 2. AT TIME OF REPLACEMENT, FILL OUT WEB FORM AND SUBMIT at http://www.sunpath.com/MetalFlexRecall.html and add "<i>-Replaced</i> " after SPSB009 COMPLETED from step 1 above. 3. NO FURTHER ACTION REQUIRED
	sure to inspect the section that is routed through the chest strap. <i>Inspection Results:</i> A. HOUSING FOUND TO BE INTACT (GOOD): The rig may continue to be jumped with periodic monitoring until the next repack cycle or earlier elective replacement. However this housing must be replaced at the next repack cycle. See <u>http://www.sunpath.com/support/HousingReplacement.pdf</u> for instructions for your rigger to complete the replacement of the housing. B. HOUSING FOUND TO BE SEPERATED/UNRAVELLED (BAD): The housing must be replaced before the next jump by a certificated senior or master parachute rigger (or foreign equal) or the manufacturer. See <u>http://www.sunpath.com/support/HousingReplacement.pdf</u> for instructions for your rigger to complete the replacement of the housing or instructions for your system back to the manufacturer.
