## **TECHNICAL & SAFETY COMMITTEE**

Technical & Safety Information Notice No.	02/2011 MarS Ripcord Handle Pins W.N. 37
Date of Issue	24 February 2011 - Note – while the MarS Service Bulletin is dated September 10 <sup>th</sup> 2010, it was received by the T&S Committee on 24 February 2011.
Subject Matter and Applicability	MarS a.s., Okružní II. čp. 239, 569 43 Jevíčko BULLETIN CZECH REPUBLIC C+M
	SERVICE BULLETIN No. 11/09/2010
	Check of Ripcord Handle Pins

SERVICE BULLETIN

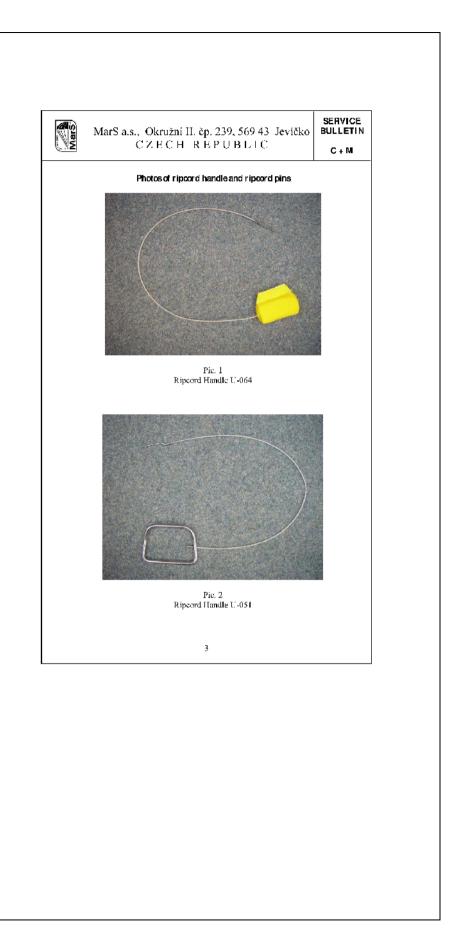
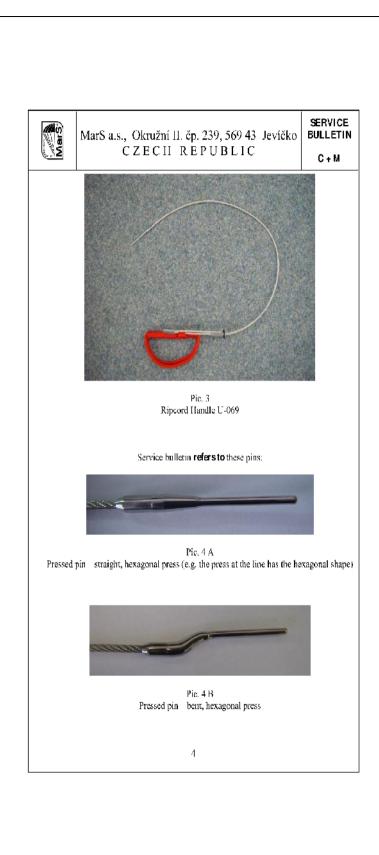
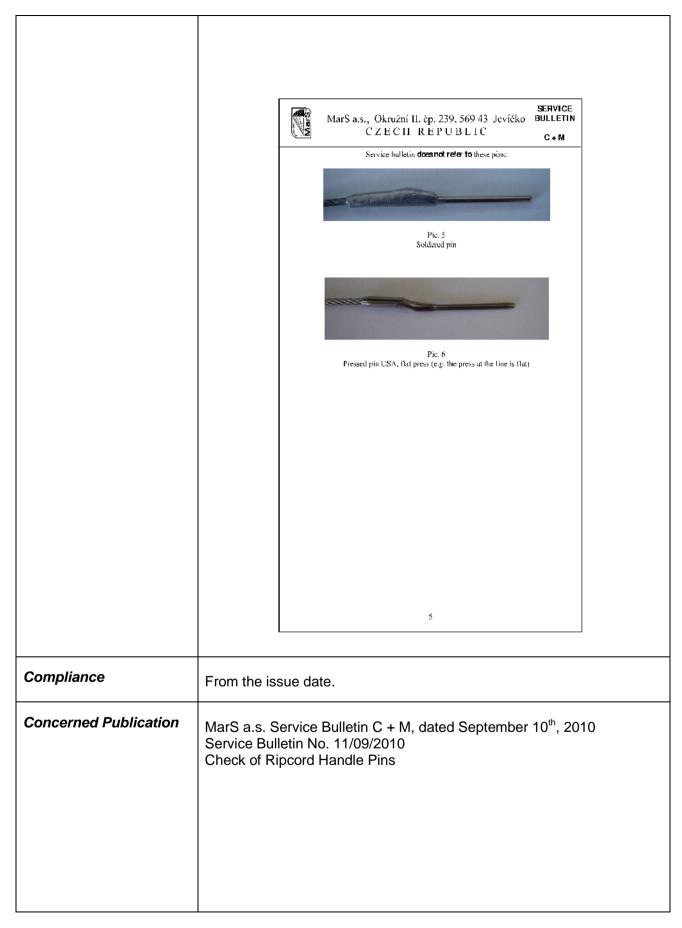
1. APPLIESTO: the pins of ripcord handle reserve parachutes U = 064 ( pic.1), U = 051 ( pic.2) and U = 069 ( pic.3), produced by Synck company ( pressed pins = hexagonal press, see pic. 4 A - straight and pic. 4 B = bently, which are parts of: Parachute sets Real = X, OP-103/PS-034 S (U = 051) OP-103/PS-034 S (U = 051) OP-103/PS-035 (U = 064) Containers of parachutes with harness OP-087/PS-034 S (U = 051) OP-087/PS-034 U (U = 064 or U = 051) OP-087/PS-034 U (U = 064 or U = 051) OP-087/PS-034 U (U = 064) OP-087/PS-034 U (U = 064) OP-093/01/PS-034 S (U = 051), and Parachute sets MarS = T, OP-095T/PS-052T(1 = 069), delivered by MarS a.s. Jevíčko, used in civil aviation, and further Parachute sets M 282 a M 291 (U = 051). and Parachute sets PPSO CZ 330(HOP 330) (U = 069), delivered by MarS a.s. Jevíčko, used in military aviation.  2. REASON: During multiple tests for attestation of power for tearing off the ripcord handle it was found out gradual increase of the power beyond the permissible range that is defined by the regulation (22,2 to 97,9 N). During analysis of this situation it was found out that during the multiple tearing-off the ripcord handle the surface of the ripcord pin body can be damaged. This state can further cause an increase of power needed for tearing off the ripcord handle.

5. ATTACHMENTS: Attachment no. 1 Photos of ripcord handle and ripcord pins

<ul> <li>3. MEASURES: - A user or a packer licensed to pack the reserve parachuses (authorized person) proceeds a check of the ripcord handle pin at the products mentioned in part 1 and in case the pin body is found damaged, he/she puts the parachute set out of service.</li> <li>- Further he/she sends a report with the type number of the ripcord handle and also the length of the ripcord handle at the type U-064 and U-051 to MarS a.s. Jevičko to the fax number + 420 461 353 861 or to an E-mail mars/marsjev.ez.</li> <li>- The producer sends the new ripcord handle to the user free of charge.</li> <li>- The user sends the original part of the ripcord handle back to the producer.</li> <li>- In case there is also excessive damage on the flap grommet, which is placed under the ripcord handle pin body during packing, the user send-the container of the parachute with harness and with</li> </ul>

the ripcord handle reserve parachute, or the whole parachute set back to the MarS a.s. Jevičko for the examination.

- MarS a.s. Jevičko proceeds professional check of the state of the ripcord handle pin and the grommet and based on the results of the examination they exchange the parts concerned.
