## DHV Accident Report 9.01.2011

Date	18.12.10	Time	15:15:00
Land	Germany	Site	Brauneck
Pilot	32 years old, DHV A-Licence since 2004	Experienced Acro-pilot	
Equipment: PG	U-Turn Thriller 20m <sup>2</sup> acro glider	Tested by	Not tested
Weight range	90-120kg	Pilot start weight	
Harness	Ava Sport Acro with foam protector and 2 underseat reserve containers	Reserve	1. Team 5 Orange ST steerable 2. Independence Seven Up L
Pilot Injuries	Fatal	Passenger Injuries

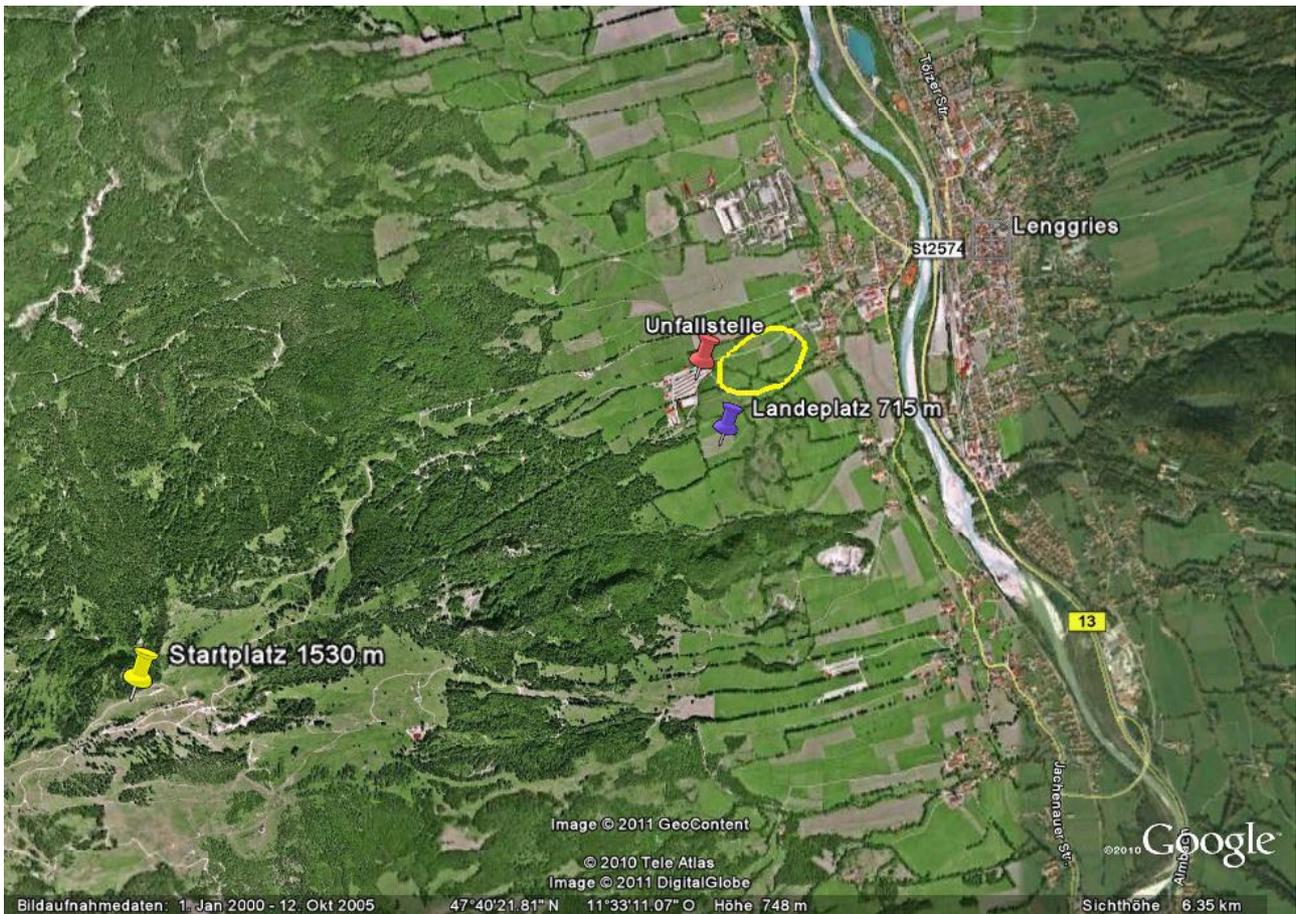
*Picture 1: The Brauneck site with start “Startplatz”, landing “Landeplatz” and accident “Unfallstelle” indicated. The yellow circle indicates the area where acro flying is permitted. Acro flying is only permitted here, so as not to endanger other pilots preparing to land, or people on the ground.*

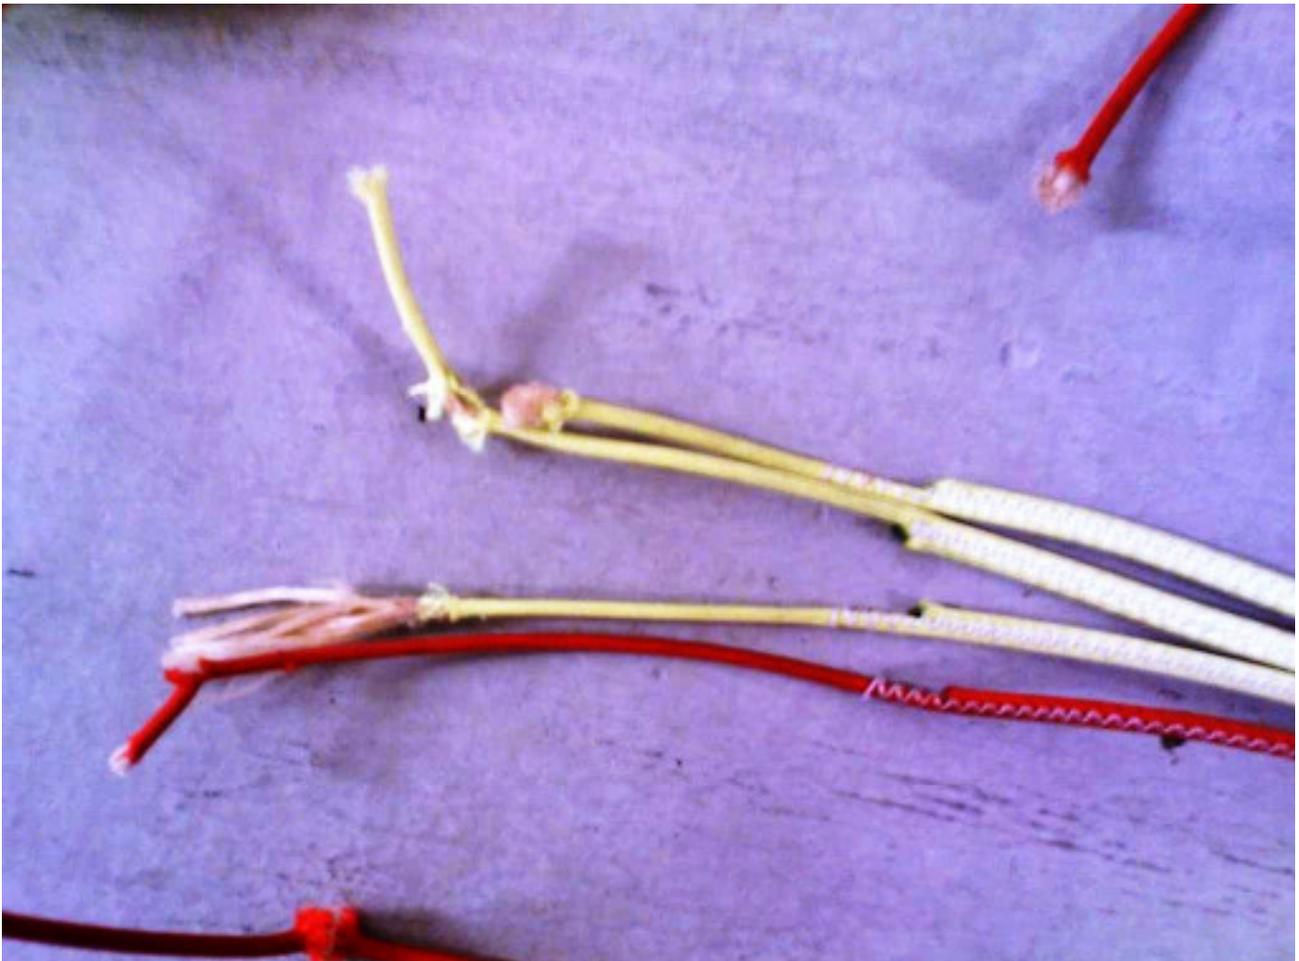
The glider was in good, nearly-new condition. There were no signs on the canopy which indicated a material failure which may have lead to the accident. Several lines had been cut to free the pilot at the site of the accident. The use of differing tools to cut the lines was evident on the investigation of the cut lines. Cleanly severed lines cut by a sharp knife contrasted with the ragged edges of those cut with a pair of blunt household scissors. Pictures of the differently cut lines were presented to competent examiners, who were all certain that this type of cut could not have resulted from overloading, but must have been made with a knife or other blunt tool.

*Picture 2. Ragged edged cut lines from part of the canopy line set. On one part of the line set, lines had severed directly above the sewn part of the lines.*

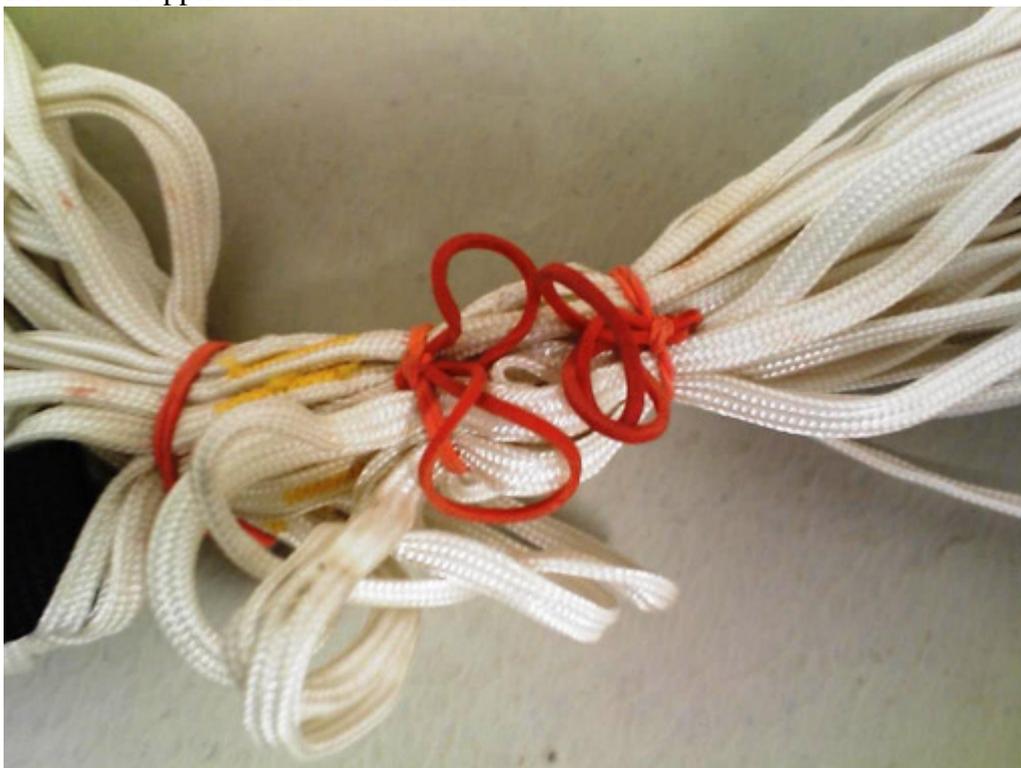
The pilot had successfully deployed his reserve a few weeks prior to the accident after an acro manoeuvre went wrong. After this, he had packed the reserve himself and re-installed it in his harness. The pilot had used knotted household rubber bands to secure the reserve lines above the reserve risers, probably because the velcro closure on the harness was too small to cover the connecting line correctly. These rubber bands were still intact, and would have released had

minimum force been applied. This was not the case.

*Picture 4. Unreleased rubber bands above riser attachment point on Orange ST reserve.*

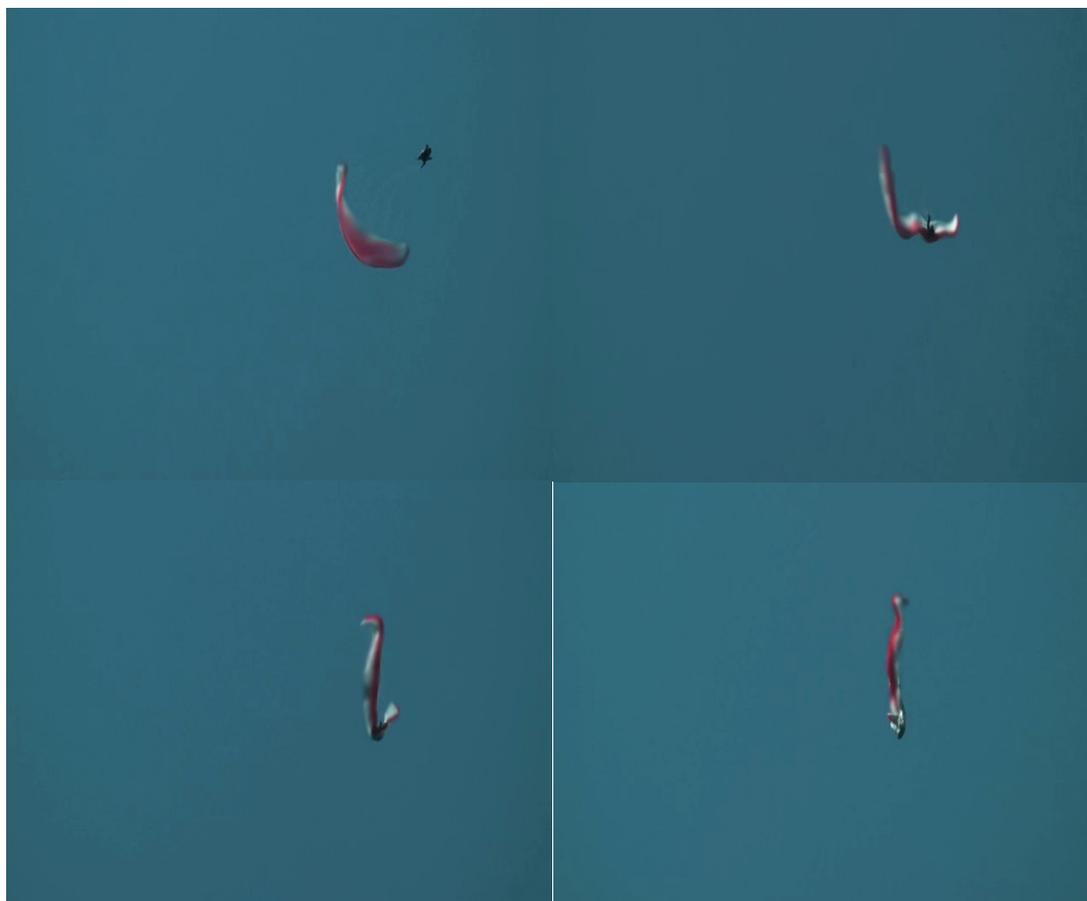
*Pictures 5-8: these pictures (of a different accident) indicate the sequence of events. Top left: the pilot begins to fall towards the glider, contact with the canopy after 0.7 seconds (top right). At this moment the reserve deployment was witnessed. The reserve became tangled in the main canopy as it rose up asymmetrically within a further 0.3 seconds (lower left) and did not open correctly due to this. Lower right: the pilot is completely wrapped in the glider and falling at high velocity to the ground.*
