TECHNICAL & SAFETY COMMITTEE

INTERNATIONAL PARACHUTING COMMISSION

Technical & Safety Information Notice No.	W.N. 52 Subject: Vigil Cutters manufactured March 2015 – July 2015 (03/2015 – 07/2015) The full list of the Serial Numbers of the units affected is to be found in the Service Bulletin Number PSB 01-2015 on the Vigil website – www.vigil.aero
Date of Issue	12 November 2015
Subject Matter and Applicability	PRODUCT SERVICE BULLETIN Issue Date: 09 November 2015 Bulletin Number: PSB 01-2015
Details	<p>Identification: All Vigil AAD cutters with Date of Manufacture from 01 March 2015 through 31 July 2015. (3-15, 4-15, 5-15, 6-15 and 7-15) (mm-yy), whether or not the cutter is actually installed in a harness-container AAD system. The full list of the Serial Numbers of the units affected is to be found in the Service Bulletin Number PSB 01-2015 on the Vigil website – www.vigil.aero</p>

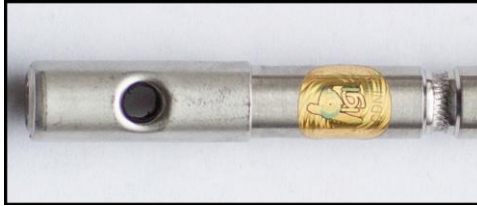
The hologram number (Gold) on your cutter is the same as the hologram number (Gold) mentioned on the Certificate Card that was delivered to you together with your Vigil assembly. If you can't retrieve your Certificate Card you can check the back of your original Vigil control unit, if accessible (harness-container dependent).

The hologram number (Gold) on the back of the original control unit is the same as the one on your original cutter. If you are unable to check the back of the original control unit, you can verify the serial number of your Vigil using the info menu during start up of your Vigil. For more information on accessing the start up menu, if necessary, please consult your manual or our website (www.vigil.aero).

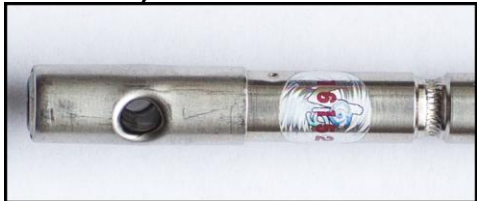
The hologram number (Silver/Red) on your cutter is the same as the hologram number (Silver/Red) on your Service Card that was delivered to you together with your replacement cutter. If you cannot retrieve your Service Card you will have no choice but to visually check the hologram placed on your cutter.
