<p><b>Technical &amp; Safety Information Notice No.</b></p>	<p><b>W.N. 54</b></p> <p><b>Subject: DSF Stainless Steel Hardware on Vortex Harness Containers</b>                  PRODUCT SERVICE BULLETIN 2016-01 (PSB # 2016-01)  <b>Update 2.</b></p> <p><b>Correction to Original Bulletin PSB#2016-01</b></p>
<p><b>Date of Issue</b></p>	<p><b>07 March 2016</b></p>
<p><b>Subject Matter and Applicability</b></p>	<p><b>Affected Vortex Rigs: All Harness Containers fitted with Stainless Steel DSF hardware.</b></p>
<p><b>Details</b></p>	<p>A small number of harness containers were produced by Parachute Systems in 2011 with stainless steel base ring as pictured below:</p> <div data-bbox="777 963 1175 1566" data-label="Image">                  A close-up photograph of a person's hand holding a stainless steel base ring. The ring is stamped with the letters 'DSF' and the number '11'. It is being used to secure a dark, textured fabric strap with yellow stitching.             </div> <p>These DO form part of the recall and are in addition to the ones referenced in the original Bulletin (PSB#2016-01) stamped "DSF". We were unaware that the manufacturer changed their stamp on the rings at the time we

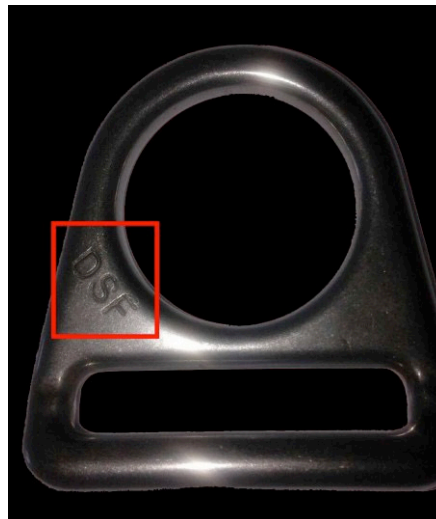
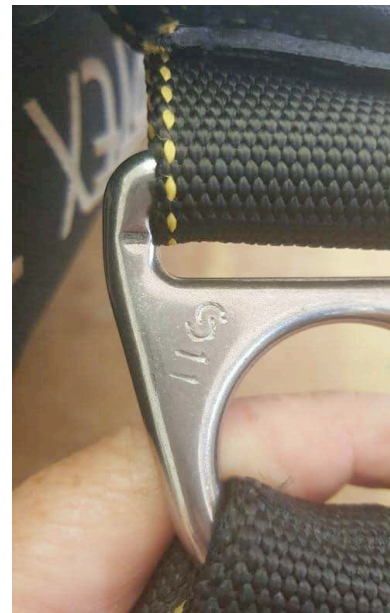
**STATUS:** All Harness Containers with Stainless Steel base ring hardware stamped DSF AND with Daesung logo are Permanently Grounded (Product Recall)

All DSF/and Daesung logo printed Stainless Steel Hardware (Part Number: H38005) ,this includes the stainless steel mini base ring and hip and chest rings identifiable by DSF stamp and logo stamp as in picture below.

On January 2nd, 2016, a photograph of a stainless steel ring with DSF imprinted on it was sent to us by our dealer in Holland. This ring was observed by a jumpmaster/loader prior to boarding. We think the ring cracked and was pulled apart by about ten millimeters on one side, on the previous opening. The harness/container only had four jumps on it, according to the dealer. Without much information and due to the holiday weekend, we were unable to assess exactly what had occurred and we

**Harness containers with stainless steel base rings with either or both of these stamps are immediately grounded and affected by the recall.** These should immediately be registered and returned for replacement.

2. It has been decided, therefore, that every Vortex Harness Container with the stainless steel hardware as referenced in the Bulletin and stamped "DSF" BE GROUNDED PERMANENTLY.
